ASSESSING THE RAPID DRAWDOWN RISKS ON SLOPE STABILITY

Abstract: This study investigates the slope failure that occurred at a 152.18-acre residential development in Kulim. The unreinforced slope was reported to be deemed stable before its failure in the mid-April 2023. Continuous pumping activity for nearby basement construction had been underway for several weeks prior to the failure. To confirm the causality of drawdown effect, the groundwater level was monitored using two piezometer standpipes. The fieldwork investigation confirmed a significant difference in groundwater levels caused by the dewatering activities. By developing a numerical model using Slope/W software, slope stability analysis was performed to assess the slope performance before and after the failure, analysing the impact of dewatering. The findings revealed a significant reduction in the factor of safety (FOS) from 1.348 to 1.080, not adhering to the Jabatan Kerja Raya (JKR)'s slope specifications of a minimum FOS of 1.3 for unreinforced soil. The findings also confirmed the detrimental effect of rapid drawdown on the strength of the slope. To mitigate the slope failure, gabion walls were proposed as cost-effec

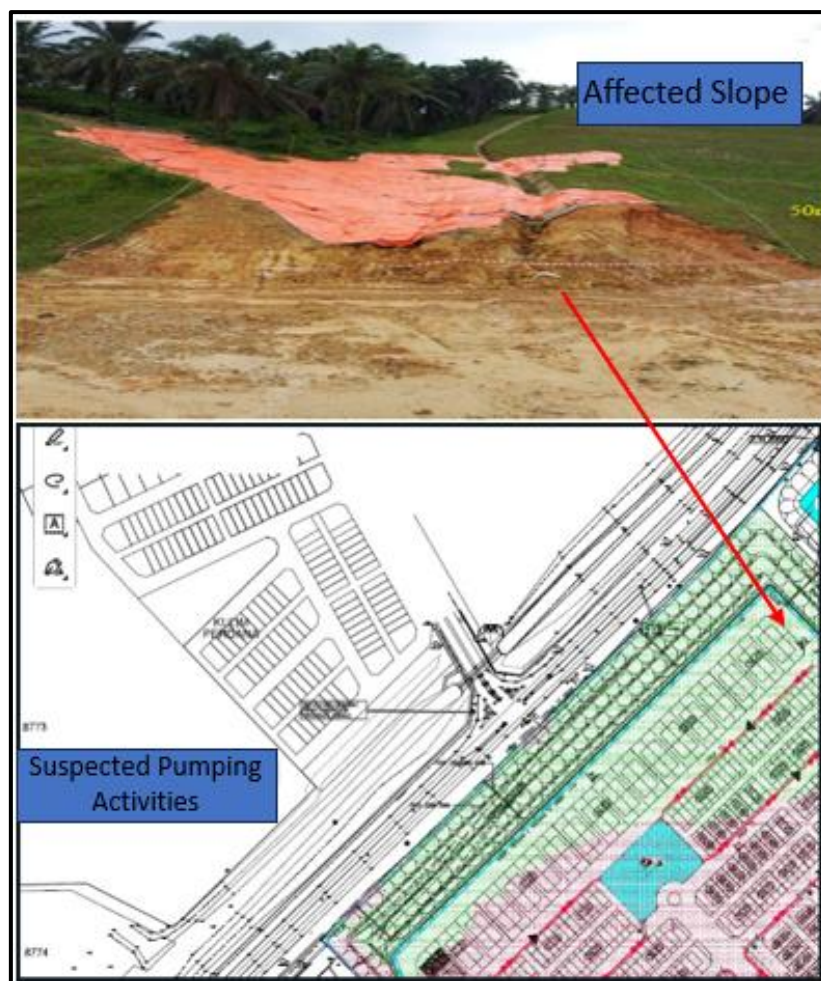
A residential development in Kulim, Kedah situated on a hilly terrain with 50m Reduced Level difference in topographical level has drawn attention to slope failure in mid-April 2023. During the site visit in May 2023, the project manager reported continuous dewatering operations for a nearby site's basement construction were underway a few weeks prior to the slope failure. A detailed location of the affected slope and location of dewatering activities close by to the residential development site is presented in **Figure 1**. The distance of the suspected activities and the affected slope is approximately 300m. To confirm the causality, a thorough forensic investigation works from a dewatering effect standpoint was carried out. The hypothesis of the study is due to the reduction of water due to dewatering causes shrinkage of the clay soil hence causing slope failure. This situation is due to the tropical climate of Malaysia which is caused by the infiltration of rainwater hence causing swelling and during the hot weather causes shrinkage of soil.

Figure 1. Affected slope and dewatering activity

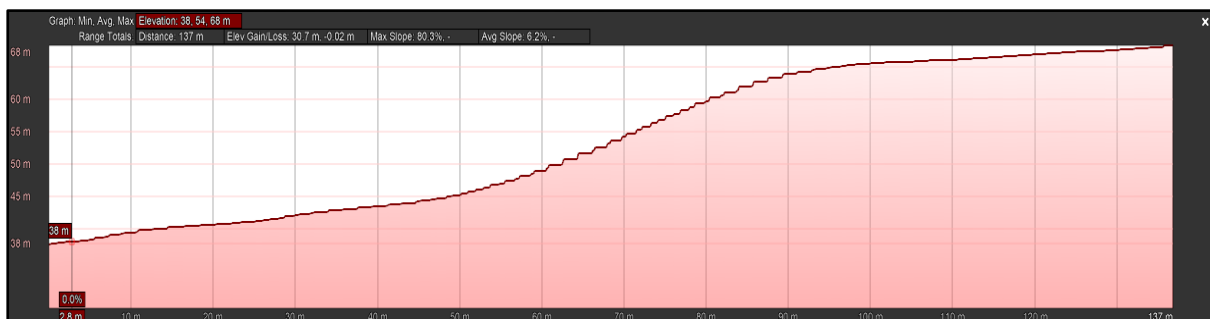
Figure 5. Cross section of slope failure

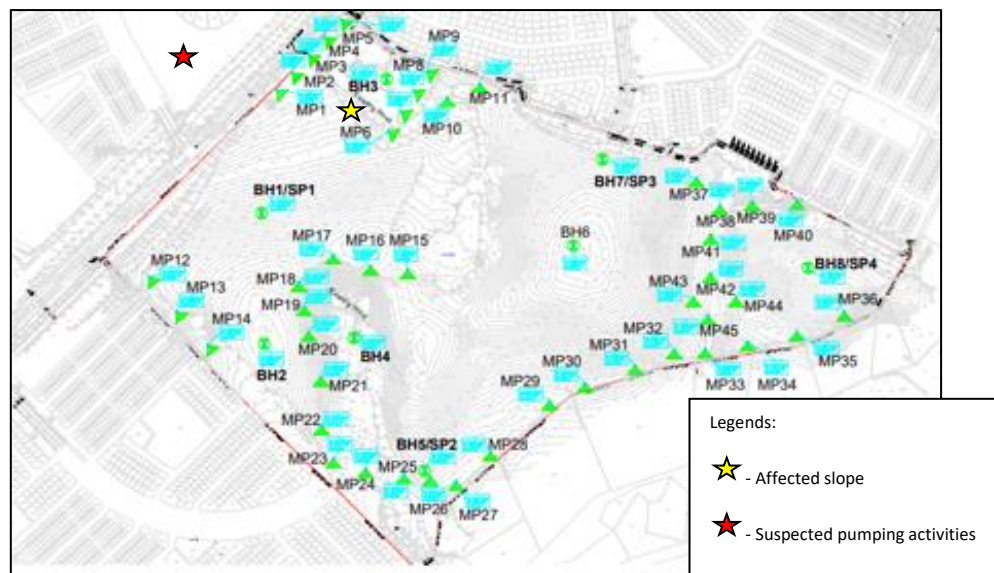
Based on the SI mapping in **Figure 6**, the existing soil data of the site at the affected slope close by to BH3 is reviewed to understand its general subsoil profile.

Figure 6. Set up of new standpipes after the slope failure

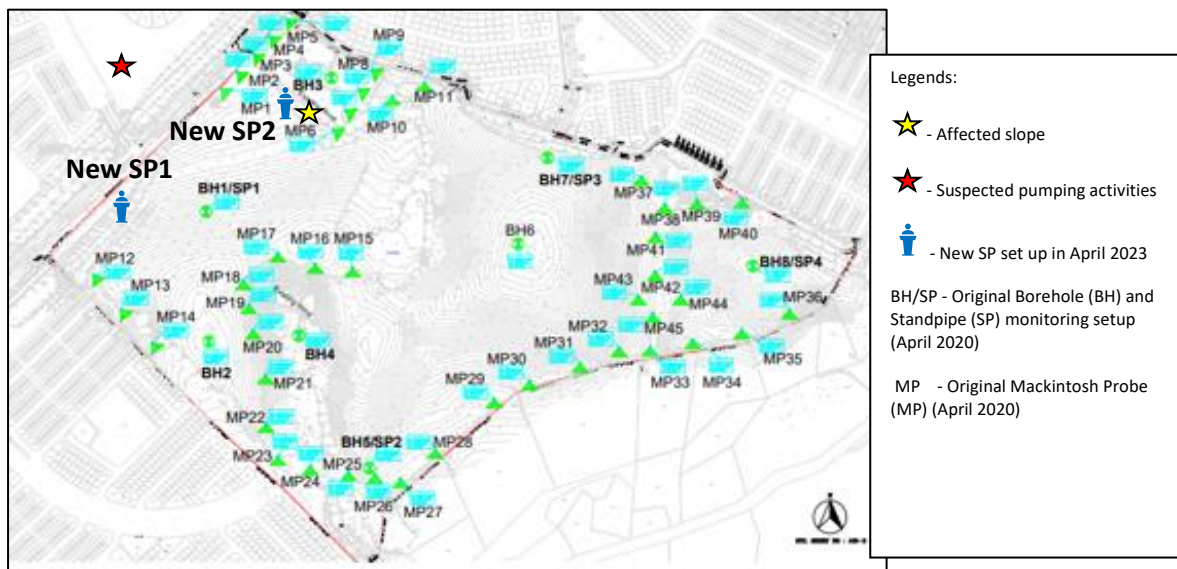
Following the slope failure incident, an additional field examination was conducted in April 2023, by setting up two (2) new standpipe piezometers (SP) to confirm the lowering of groundwater levels. These SPs were deployed along the damaged slope that is close by to BH3 and at the likely pumping site, as shown in **Figure 7**.

**Figure 7.** Original and new soil investigation works

Based on the monitored results of the newly installed standpipes, both standpipes conform the lowering of groundwater level up to around 14.25m below the ground level. To further confirm the significance of the effect of the differences between the original and new groundwater level on the slope, numerical investigations based on slope stability analysis were conducted to evaluate the factor of safety of the slope. The adopted soil data for the numerical analysis is the same as the original ground condition data.

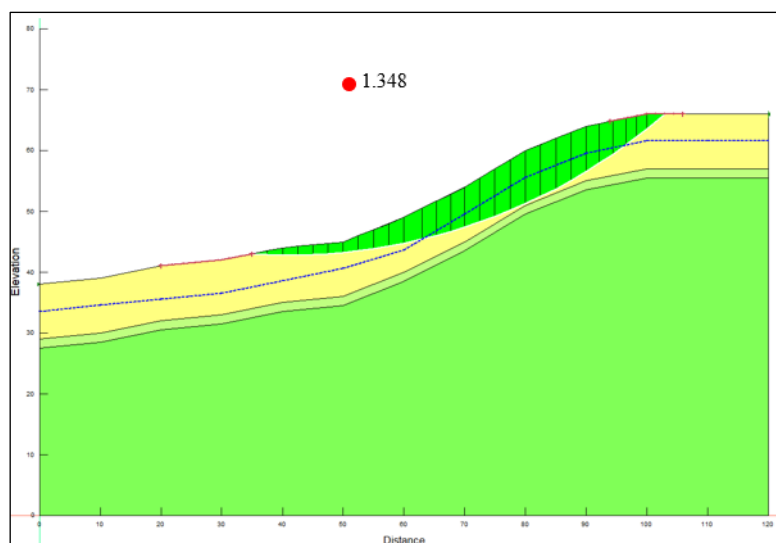
In assessing the original slope condition, a surcharge was deliberately omitted to ascertain the factor of safety (FOS) of the slope in its natural state. This approach is essential to understand the inherent stability of the slope without additional loads or modifications. By evaluating the FOS under these circumstances, engineers can establish a baseline measure of the slope's safety and identify any underlying risks or weaknesses. Hence based on the analysis conducted the FOS of the slope is 1.348 as seen in **Figure 8**.

Figure 8. Factor of safety of original ground condition

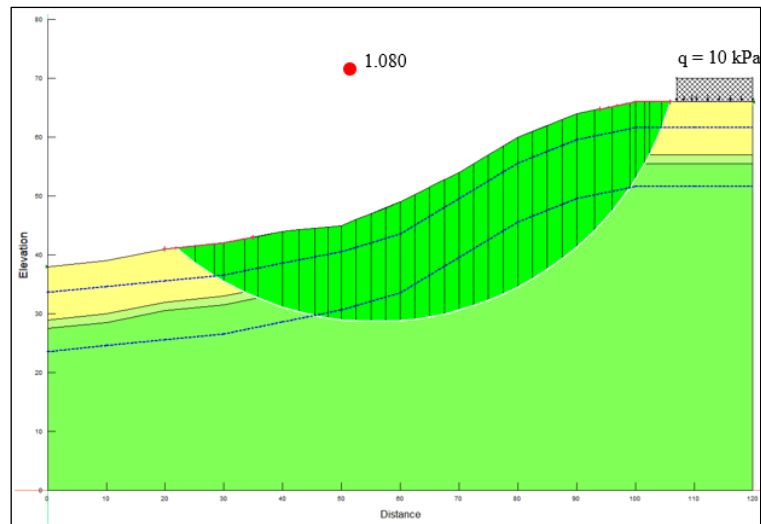
Following the slope failure, a comprehensive assessment was carried out to uncover the root causes. The slope is then modelled based on the before drawdown and after water level which is obtained from the piezometric data's. Surcharge of 10 kPa is then added to simulate in the event a development is to occur on top of the slope. Hence, once the parameters have been established, the data is placed in the Slope/W software and the Factor of Safety (FOS) of 1.080 once the reduction in water level is obtained as seen in **Figure 9**.

Figure 9. Factor of safety value with drawdown
