METALLURGICAL FAILURE ANALYSIS OF A TRICYCLE FRONT WHEEL AXLE

Muazu, A. *, Yusuf, T., Jamilu, S., Abusufyan, S. K., Elijah, U. E., Joshua, I.

Department of Mechanical Engineering, Bayero University, Kano, Nigeria.

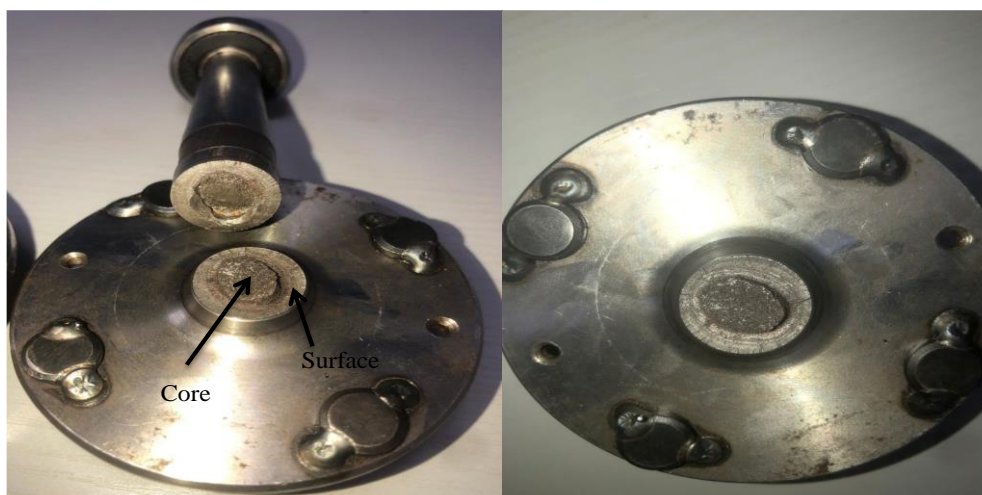
Figure 2. Fractured surface of a failed tricycle front wheel axle

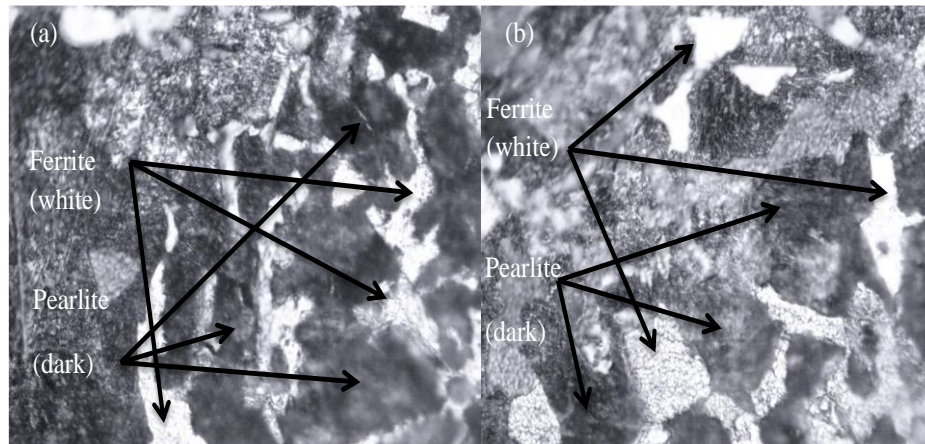
Figure 4. The figure shows the presence of relative fine pearlite (dark phase) and fine ferrite (white phase) in the microstructure in

Figure 4(a). In contrast, steels that undergo hardenability heat treatment contain tempered martensite in their microstructure at the surface of the steels, which is in the form of needle shape/acicular structures as reported by Wei *et al.* (2018) and Tawancy and Al-Hadhrani (2013). This anomaly in the microstructure of the failed surface of the axle may be attributed to improper heat treatment or no heat treatment was conducted. The axle was supposed to be

heated above the A3 for low and medium-carbon steels on the iron-carbon equilibrium diagram to obtain a full austenite microstructure before quenching.

Figure 4. Optical microstructure of failed axle (a) at *the* surface and (b) at core 500X

Figure 4b), shows a similar microstructure to that at the surface (pearlite and ferrite), however, the phases are relatively coarser than that at the surface. This microstructure is expected at the core of an axle since axles are surface-hardened to give a hardened case and a toughened core. The pearlite and ferrite microstructures are responsible for the tougher core of the axle, as they are expected to absorb energy before fracture, which is in contrast to the martensitic case which is supposed to acquire high hardness and strength.

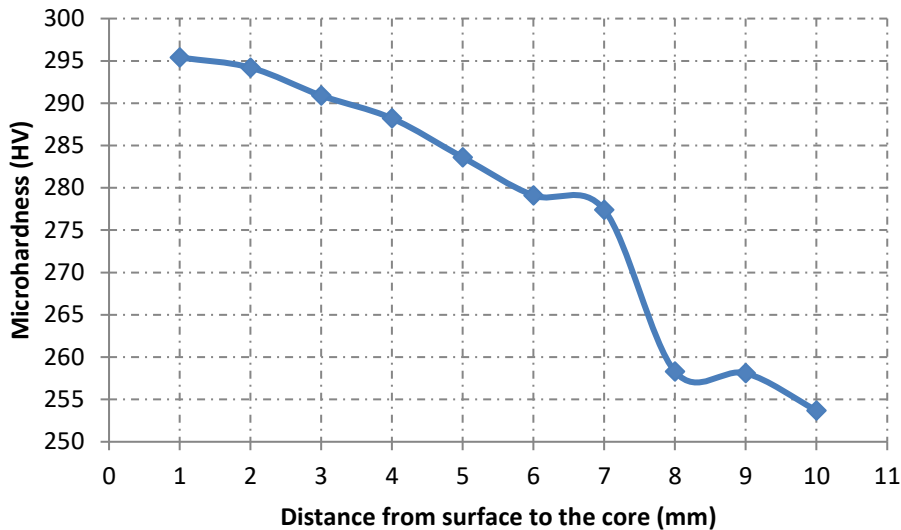
The microhardness profile of the failed axle is shown in **Figure 5**. From the figure, it shows the hardness profile of the failed axle at the core and the surface does not conform to what is obtained from the literature on a hardenable axle. The hardness values at the surface range from 277-295 HV while at the core the hardness values range from 254-258 HV. This shows that the hardness values at the surface lie below the expected hardness of axles, which is in the range of 500-550 HV. Similarly, the hardness values at the core were below that reported by some literature (285 HV) (Asi, 2006; Tawancy and Al-Hadhrami, 2013). These low hardness values at the surface can be attributed to the presence of pearlite and ferrite at the surface of the failed axle instead of tempered martensite. This further confirms that the axle was given improper heat treatment or not quenched and tempered at all. At the core, the low value of the hardness can be attributed to the low carbon content of the axle (**Table 1**) which is below the standard of carbon content required for the axle. Literature has reported that carbon in steels

improves hardness, strength and hardenability by optimizing the variant selection to increase the density of high-angle grain boundary (Tawancy and Al-Hadhrami, 2013). In addition, other alloying elements such as Mn, Cr and Mo improve the strength, hardness, toughness and hardenability of low-carbon steels (Allen and Boardman, 2005).

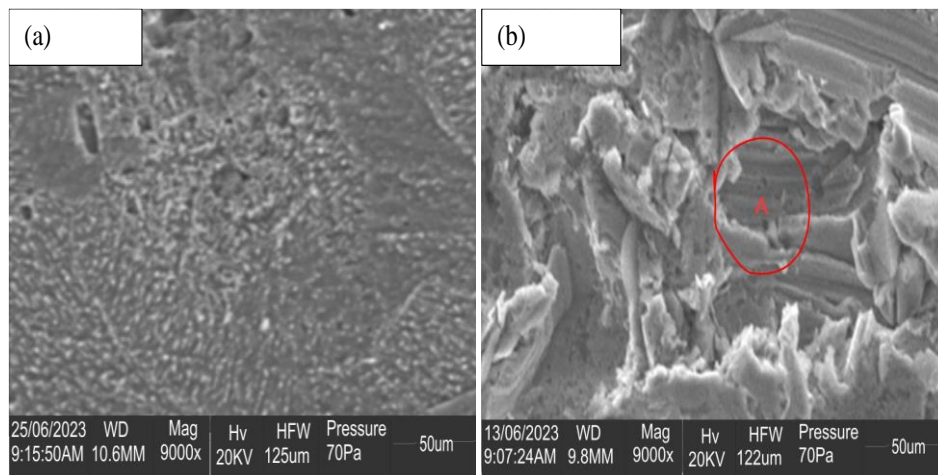
The SEM analysis of the fractured surface is shown in **Figure 6**. From the figure, it shows two distinct regions of the failed axle-surface and the core. One is the burnished surface which shows that the parts have been rubbed before the final failure (**Figure 6a**). The other section of the failed part shows a crystalline failure, which shows the final failure of the parts. This type of failure is typical of fatigue. The burnished surface indicates that there was rubbing of the parts before the final failure. The core section (**Figure 6b**) shows a crystalline type of fracture, which shows that the toughened core has absorbed lower energy before the final fracture. In addition, this region represents a dimpled fracture, which is a characteristic failure of ductile materials (Al Jabbari *et al.*, 2018). This further confirms the presence of soft and ductile ferrite and pearlite at the core. In fatigue failure, cracks or flaws normally form at the surface of the piece which propagates and results in the final failure/fracture. In this type of axle where the hardness is not up to standard, the initiation of crack and its propagation will be easier.

Figure 6. (a) SEM micrograph of the burnished surface of a failed wheel axle and (b) SEM micrograph of a crystalline core of a failed wheel axle

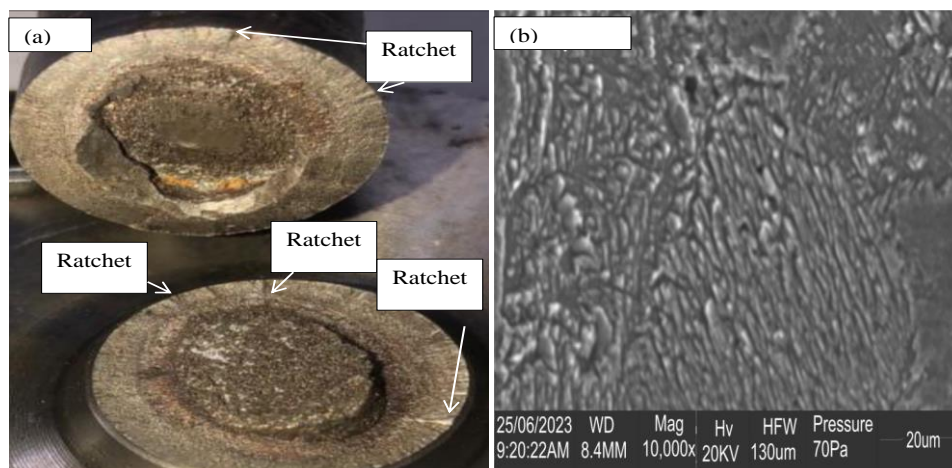
In addition, **Figure 7** shows the macroscopic and SEM images of the fractured surface. The figure shows the presence of ratchet marks separating the different fatigue zones in several locations on the circumference of the failed axle (**Figure 7a**). These irregular fatigue-shaped

cracks initiated from the circumference of the axle and propagated towards the center. A similar observation was reported by Al Jabbari *et al.* (2018). **Figure 7(b)** shows the presence of craze lines, which is evidence of propagation of the crack front during fatigue failure. Craze lines are characterized by conical-shaped features in **Figure 7(b)**. The remainder of the crack propagation occurs through both the primary and secondary craze formation (Khan, Merah and Saghi, 2007). Ratchet marks are macroscopic and in contrast, craze lines are microscopic. The presence of ratchet marks and craze lines in the failed axle further proved that the failed axle is under cyclic stress (Jeyaraj *et al.*, 2015; Puliyaneth *et al.*, 2018; Yan *et al.*, 2018).

Figure 7. Macrograph and SEM micrograph of fractured axle (a) ratchets and (b) craze lines

To avoid failure of the front wheel axle of a tricycle, agencies saddled with the responsibility of ensuring quality control such as Standard Organization of Nigeria should be investigating the quality of axles in terms of chemical, mechanical and microstructural properties.
